Building the Volvo Bertone 780 by Hand

Part 3

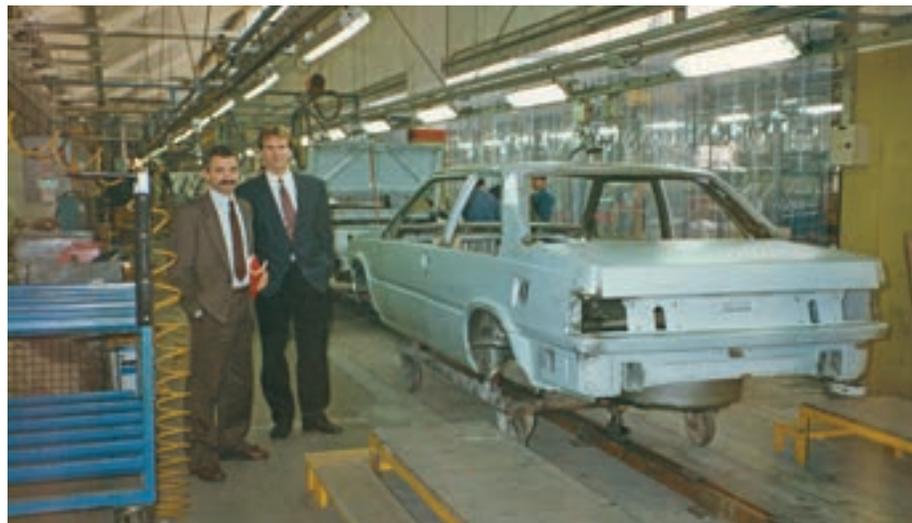
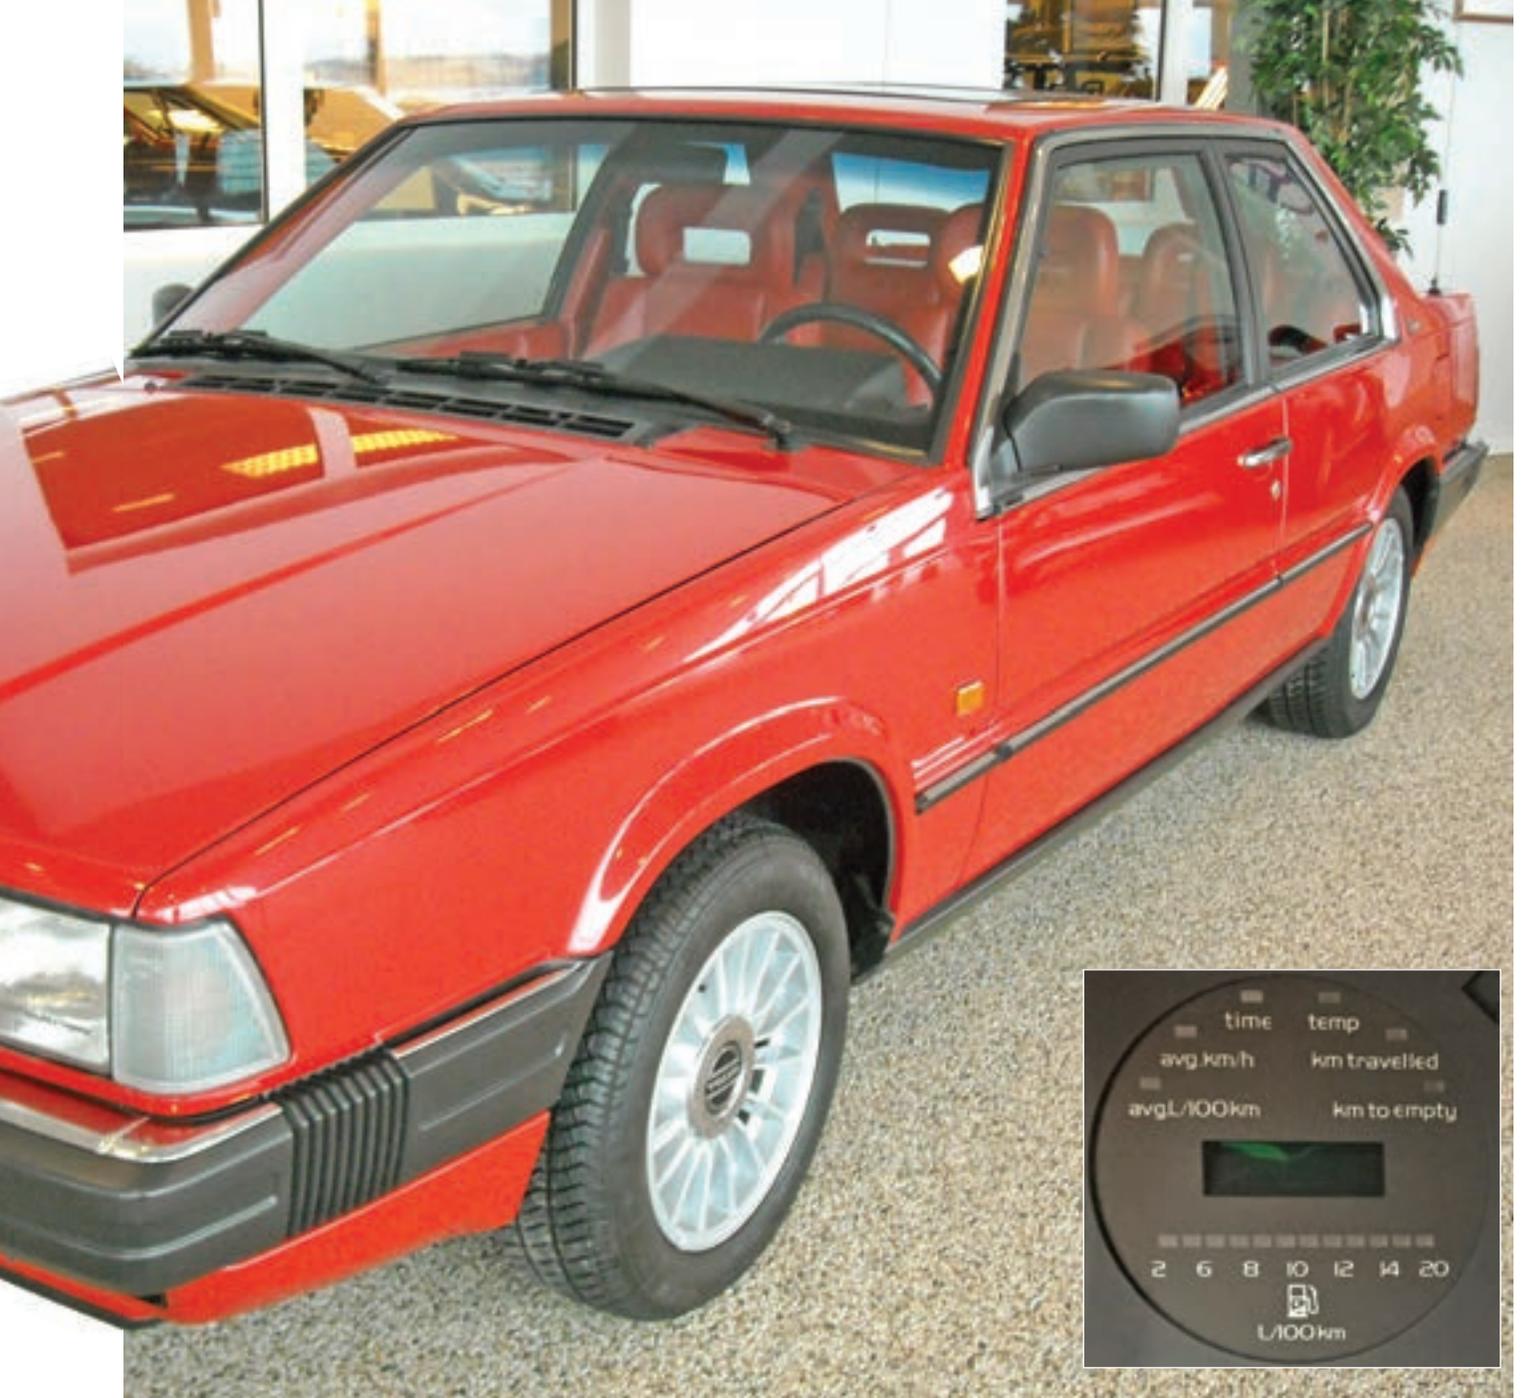
Mario Panizza and Gunnar Magnusson, Volvo's customer service representative for the 780 project, in the B Shop after the pickling bath.

Pickling may sound like something you do to a cucumber, but it is the first major step in the paint process. As a 780 enters the B Shop, other than a zinc coating, the raw steel is totally unprotected from future rust and corrosion. But given Volvo's insistence on absolute quality, and the harsh northern winters, durability and rust prevention was non-negotiable. Swedes didn't think too highly of many European cars, since the extensive use of salt during the Swedish winters quickly turned them into rust buckets.

Another name for pickling is cataphoresis. The short explanation is that the car body is lowered into a negatively charged bath, filled with a mixture of pigments, resins, and solvents. A positive charge is placed on the car, which causes the mixed solution to be deposited on all the surfaces (opposites attract), including all cracks and crevices. This film over all the bare metal forms a base layer for the paint primer, providing an excellent resistance to corrosion.

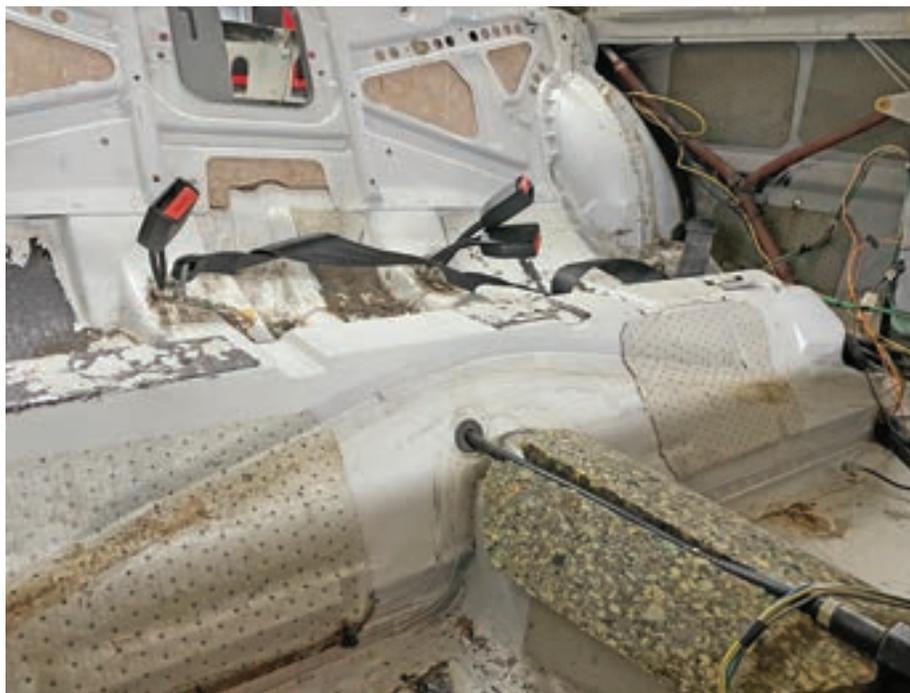
Sound-deadening panels, called dead sheets, were applied to all flat interior surfaces. They were thin, dense pieces of foam-like material with an adhesive backing and filled with small holes.

A \$43,000 automobile in the late 80s better have a quiet ride. This was achieved by adding sound-deadening panels. These thin, dense pieces of foam-like material with an adhesive backing were known as “dead sheets.” These distinctive panels, with small holes, were applied by hand to any flat interior surface—behind the dashboard, inside the doors, on the metal roof and floorboards. Anywhere it was possible to put a barrier between the passenger compartment and the outside road noise. These panels would later, during the oven-drying process, form an impenetrable bond with the metal. Later, additional foam and heavy layer sheets would be added to the floorboards. The 780 was the quietest of any Volvo in its day due to this extensive effort to ensure road noise was kept outside the passenger compartment.

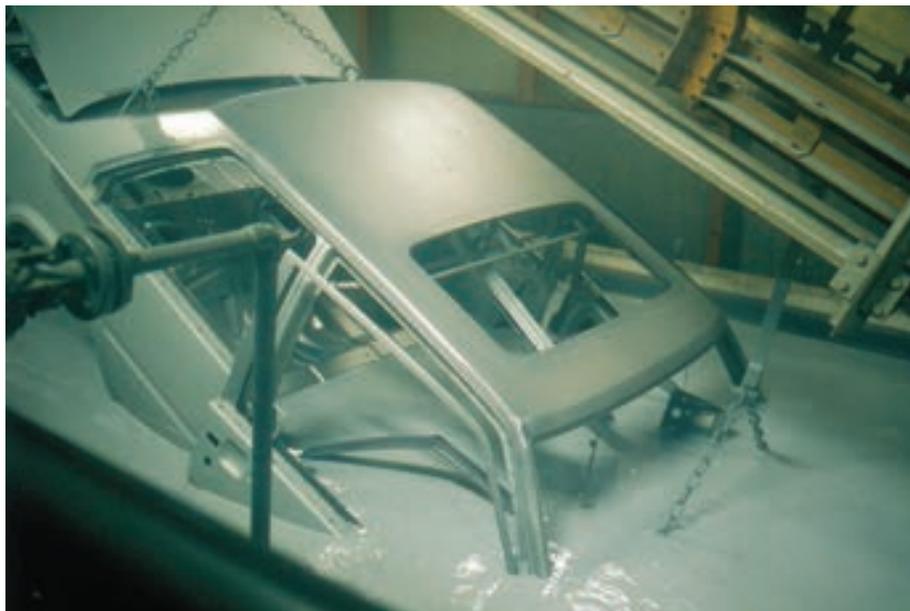
Pickling a 780 by cataphoresis in the immersion bath. This process was critical for preventing rust.

The workers connected the 780 bodies to an overhead hoist system using chains. The bodies then moved along a track allowing the entire shells to be dipped into the pickling bath. As the bodies are lifted back out of the solution, the excess liquid drips back into the bath, leaving a grey coat on the entire body, which dries fairly quickly. The heat and drying process used later in the B Shop ovens will further cure the coating. Sven-Gunnar and Mario watch as the workers return the 780 bodies to the trolleys, which are then moved forward along the track into the next area where the sound deadening panels will be installed.

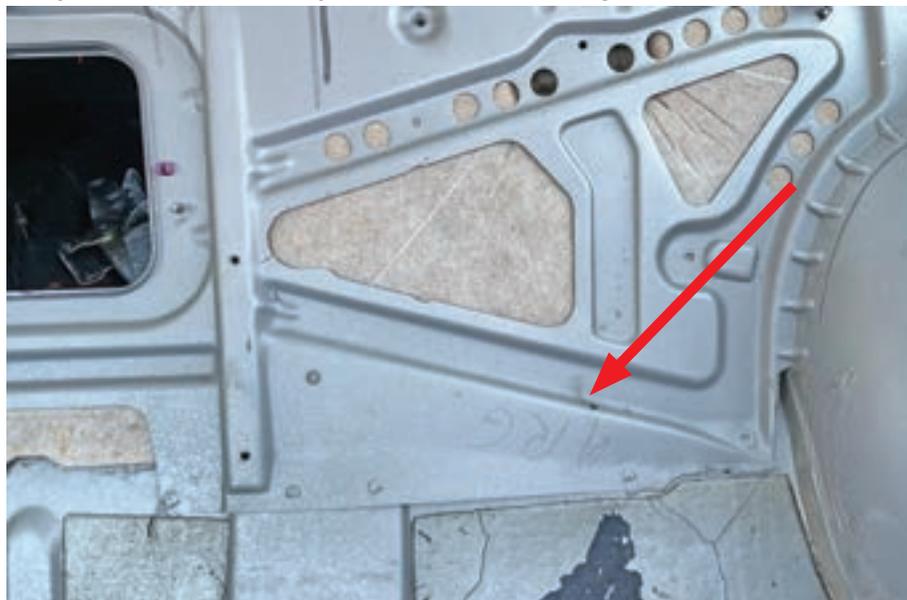
Instructions for the painters were handwritten on the metal in the backseat area. This particular car was to be painted silver (ARG for Argento).

One reminder of the handmade nature of these cars is the handwritten note that can be found on the primed metal behind the backseat that tells what color that the car is to be painted. One of my cars has *Rosso* written there and it is painted Ruby Red Pearlescent, Volvo paint code 408. Another 780 has the word *Cham* and it is painted Champagne Metallic (400). Mario explained that the purpose of handwriting the color on the car body was simply due to the fact that the printed card, which travelled with the car through the factory, specifying everything from color, to engine type and distribution market, etc. could not go through the painting process. So, the Bertone workers would place the card in a plastic envelope and then handwrite the color on the body to tell the paint team which color to use. After the cars exited the paint booths, the cards were reattached to the hood before heading to C Shop.

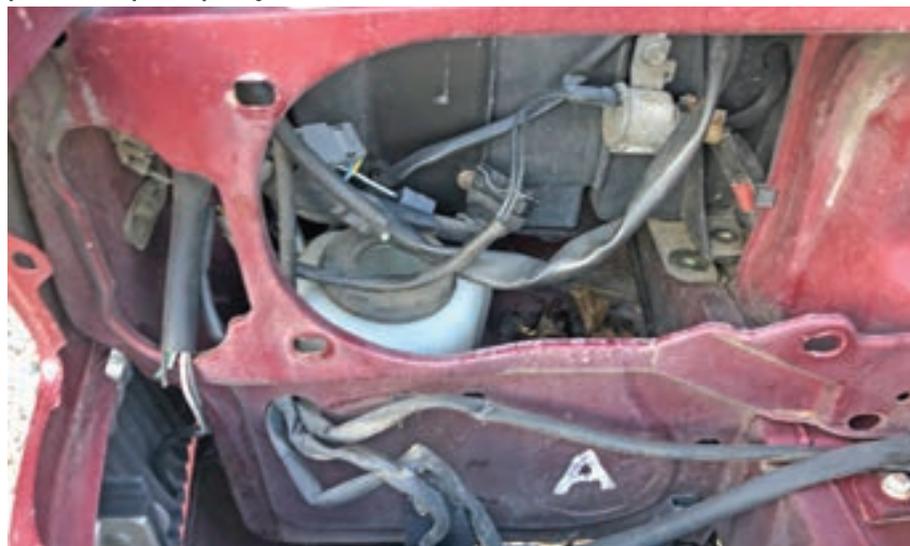
The letter A stenciled behind the passenger-side headlamp to indicate the car had passed the paint quality control.

The cars that had passed the final inspection received the letter “A” stenciled in white paint on the right front crossmember, just below where the passenger-side headlight would soon be installed. This was to confirm that the paint job met Volvo standards. If you know where to look, you can still find it there on your car.

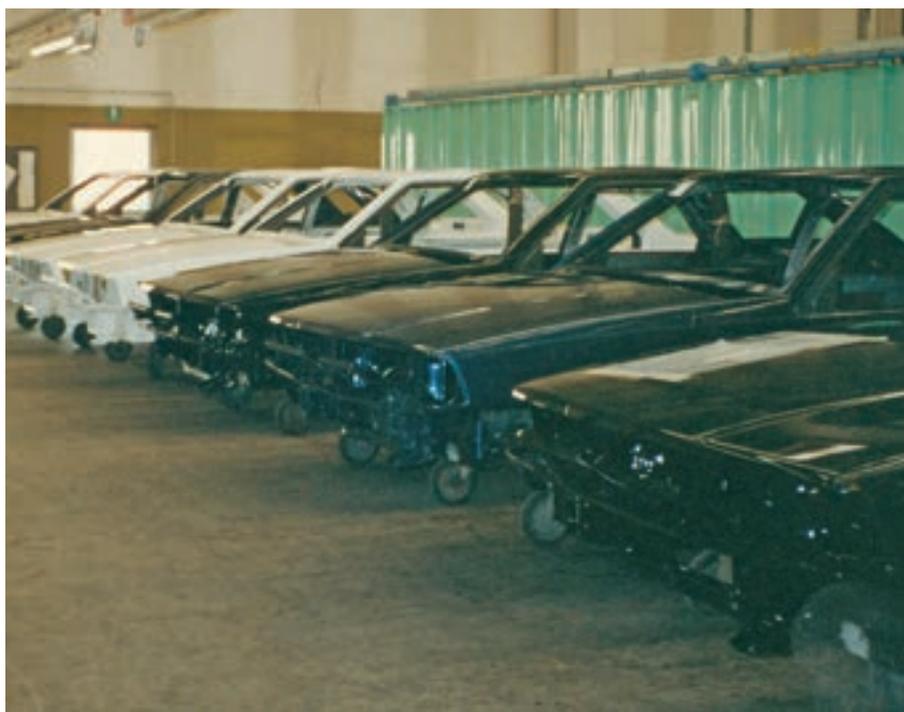
Painted bodies on trolleys awaiting inspection in the B Shop.

The B Shop inspection room looked like a large garage with long rows of painted 780s on their trolleys. One might think it was some art project with more than ten 780s backed up to the wall with their front ends almost in perfect alignment, showing a mix of black, white and
